Manhole Inspection Summary

Manhole # S19M__011MH

Inspection ☐ Is Incomplete Rating: **2) Good**

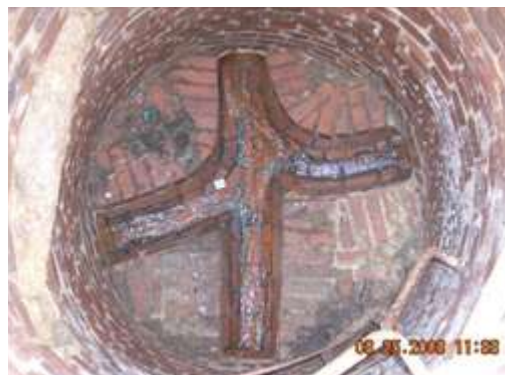
Top View

pipe coming through the corbel wall

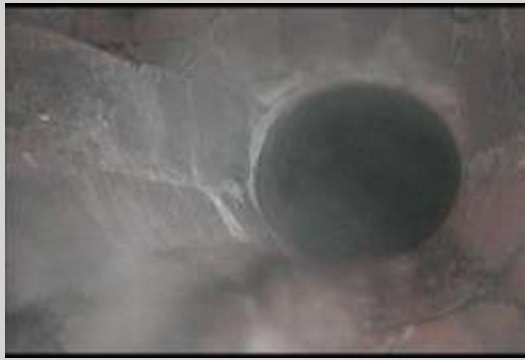
12 O'Clock Outflow

8 in. Circular Gravity Sewer
Pipe Out @ 12 O'Clock

Pipe Height: **7.2** (in.) Rod and Bar (Angled)

Pipe Material: **Clay** ☐ Pipe Lined

Invert Depth: **9.20** (ft.) Flow Characteristics: **Slow**

Infiltration: **None** Pipe Seal Cond: **Sound**

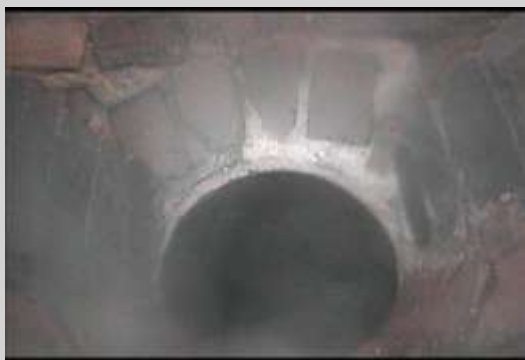
2 O'Clock Inflow

8 in. Circular Gravity Sewer
Pipe In @ 2 O'Clock

Pipe Height: **8.4** (in.) Rod and Bar (Angled)

Pipe Material: **Clay** ☐ Pipe Lined

Invert Depth: **9.17** (ft.) Flow Characteristics: **Slow**

Infiltration: **None** Pipe Seal Cond: **Sound**

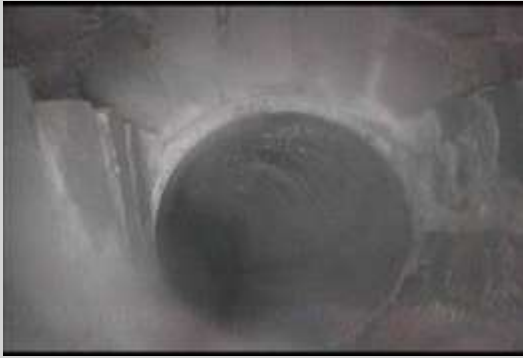
6 O'Clock Inflow

8 in. Circular Gravity Sewer

Pipe In @ 6 O'Clock

Pipe Height: **7.2** (in.) Rod and Bar (Angled)

Pipe Material: **Clay** ☐ Pipe Lined

Infiltration: **None** Pipe Seal Cond: **Sound**
